1. Brookshill Drive and Grimsdyke Estate Conservation Area Appraisal and Management Strategy	2
1.1 Introduction to the Conservation Area	2
1.1.1 Introduction	2

1.1 Introduction to the Conservation Area

1.1 The Brookshill and Grimsdyke Estate Conservation Area lies in the north of the borough and is made up of three character areas - Brookshill Drive, the Kiln, and Grimsdyke Estate. Old Redding (formerly Wealdwood Road) links Oxhey Lane with Brookshill High Road and divides the three areas, which are linked by their rich rural characters and limited modern development. Brookshill Drive is largely bounded by fields, whilst the Kiln site on Common Road is surrounded by dense vegetation and Grimsdyke Estate is sandwiched between Harrow Weald Common land, with Scheduled Ancient Monument Grim's Dyke framing the north and east. The layout of vernacular agricultural, domestic and brick production buildings and structures and Tudor style estate properties is essential to the special character of the whole area, which is also derived from its woodland, open spaces and long views over open landscapes. The area is a popular outdoor retreat easily accessible from the city.

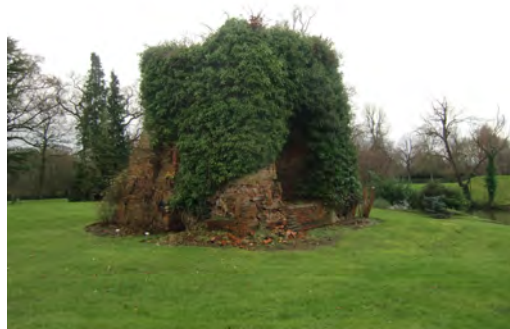
Picture 1.7 The surviving grade II listed kiln, Brookshill

1.70 The kiln itself is important architecturally as the only survivor of three which were in operation between 1795 and 1895 and a good indicator of its type. They were coal-fired and probably built by John Bodimeade to replace an earlier wood-fired kiln. Historic map evidence and a painting by

Frederick Goodall RA from c1889 show that the kiln was surrounded by lean-to buildings which were probably removed soon after the kiln closed. It is estimated that the kiln would have had a capacity of around 13,500 bricks. They were coal-fired and probably built by John Bodimeade to replace an earlier wood-fired kiln.

1.71 It stands on a grassed mound and is square in plan. It is built of soft red brick set in lime mortar with an inner lining of bricks set in loam. The walls survive to a height of 5.5m and were topped by a conical stack, taken down in the mid-C20, to give an original height of c11m. The kiln is set on a high thick brick plinth which has relieving arches on the south-west and north-west. The corners are strengthened with angle buttresses. The walls of the kiln have brick relieving arches which supported the weight of the conical chimney and allowed for the necessary repair of the chamber walls. The arch on the north-west elevation has been opened up. On the north-east elevation is a narrow segmental-headed wicket entrance. The solid brick and tile floor is a later replacement. The original floor would have had slots to allow the flames from the below ground fire tunnels.

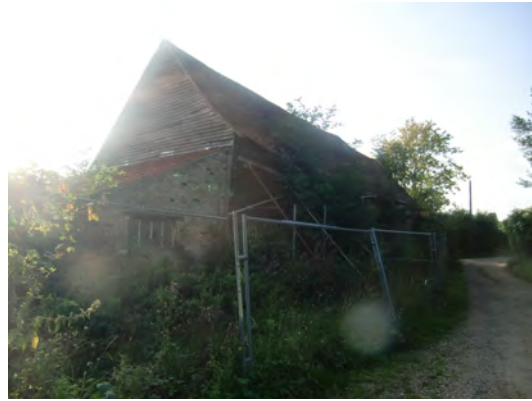
Picture 1.10 Copse Farm Barn is in need of restoration

barn which dates back to the late 18th century or earlier. Historic England have commented on Copse Farm Barn, that it is an interesting building that sits well on the lane and is the visual focal point of the group. The restoration of this site has a strong local backing.

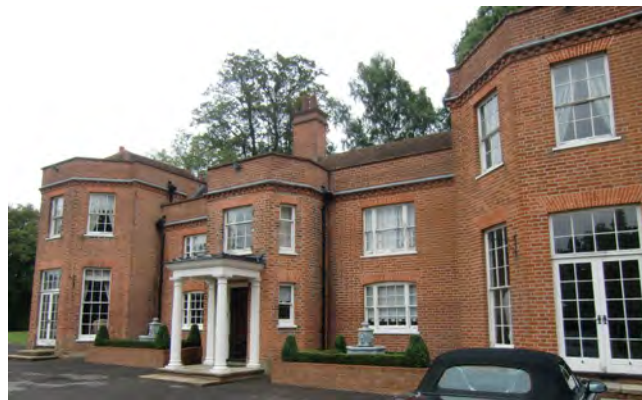
Picture 1.21 The Kiln house provides an architectural focal point

1.37 The striking Georgian appearance of the Kiln house provides an architectural focal point for the site as this house with 16th century origins was remodelled then to create a dwelling of greater architectural pretension, the external walls rebuilt in brick and a new wing added on the west side. The large 1980s east wing and classically inspired porch further increases the intended grandeur of the house. Nevertheless, the original elegant rural vernacular medium scale villa character remains apparent. Similarly the listed Kiln opposite, the pond and the adjacent wells and replica drying sheds to the Kiln house add architectural qualities and historic character of the site as a historic brick making area.

1.68 The two storey vernacular rural villa style Kiln house (dating back to the 17th century) provides an architectural focal point given its 18th century remodelling. This is apparent in the red brick laid in Flemish bond with some contrasting burnt bricks, dentilling to the parapet and clay tile roof, a canted west wing and windows are timber multi-pane sash windows with gauged brick arches above, some tripartate, most replaced in 1984. The east wing is an addition from 1984 which increases the intended grandeur of the house.

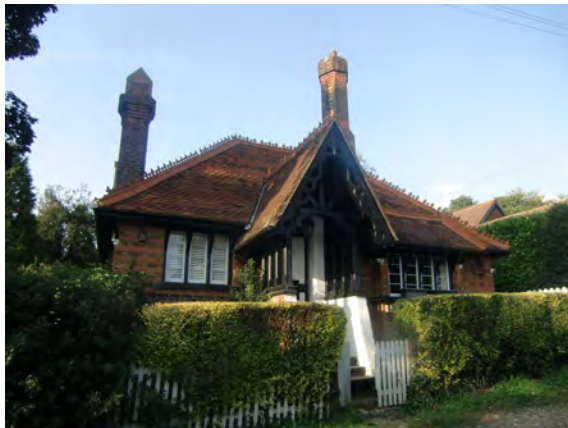
**Picture 1.31 Bridge Cottages LBH
LA.100019206.2013**

1.62 Statutorily listed grade II, Bridle Cottages, formally called the Bungalows, were built by Samuel John Blackwell in 1890 to serve Copse Farm. Constructed from Blackwell Kiln brick, the cottages were built by local bricklayer's apprentices as a testing ground for their techniques. As a result, unusual examples of tuck pointing, face bedded bricks, and alternate bands of yellow and red stock brick decorate the properties. Shaped and coloured tiles have also been woven into the roof design.

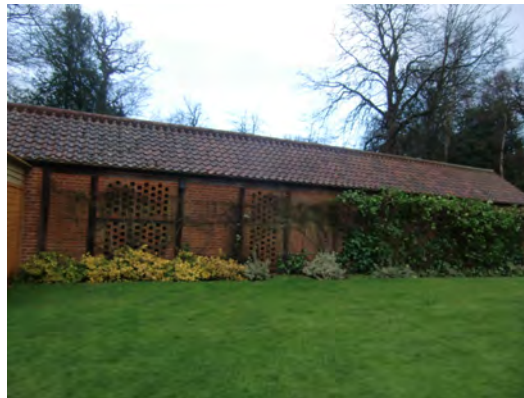
Picture 1.34 Replica drying sheds within the Kiln site, Brookshill re-using original clay pantiles

1.72 The original drying sheds were thought to be 18th century in origin and were replicated in the 1980s re-using some of the original clay pantiles. For this reason it is a single storey, elongated building. Both the north-east and south-west long elevations have open-work brick panels with timber-framing. These refer to the construction of the original drying sheds where the open-work allowed airflow through the sheds but the rebuilt panels are purely cosmetic as they are backed by solid brickwork.

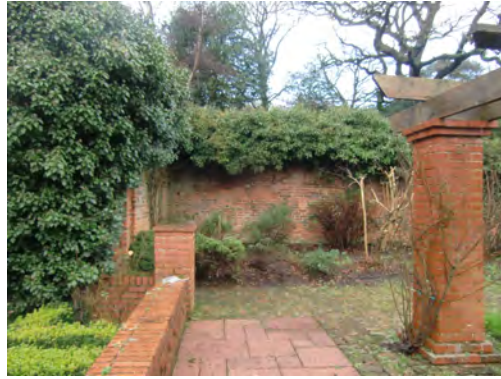
Picture 1.35 18th century brick walls to formal garden at the Kin, Brookshill with 20th century additions to the front

1.73 The garden walls are historically and architecturally important for consisting of tall sections red brickwork to the north-west and north-east, laid in Flemish bond with some blue headers and probably of C18 date. A further section, with several internal buttresses, survives on the south-west side where the majority of the C18 wall has been demolished and replaced with low open-work walls to create a fore-garden. These walls are of C20 date and have soldier-course capping and square piers with stone caps.

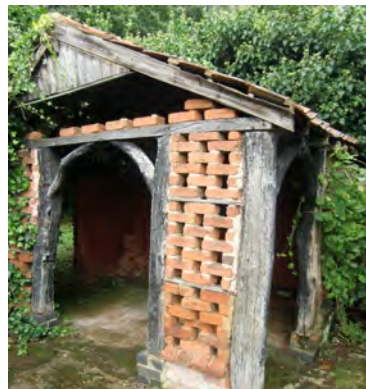
Picture 1.36 Summer house within the garden to the Kiln, Brookshill

1.74 The small arbour or summer house is incorporated at angle to the north-east wall of probable late-C19 date. This has two faces of solid brickwork, and two of open-brick work which have entrances framed with rustic timberwork. It has a pitched roof with clay pantiles. It provides a good and unusual focal point at the end of the formal walled garden.

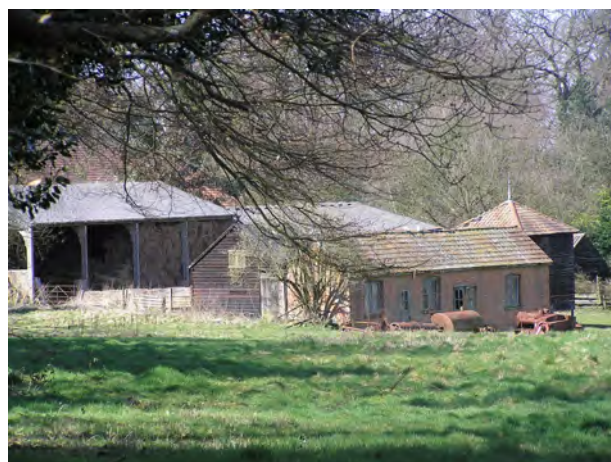
Picture 1.41 Gilbert's Model Farm

1.83 The walled compound of Gilbert's model farm still stands along with some of the buildings beyond. The wall is in relatively good condition and should be retained. Similarly a number of the barns and outbuildings/farm buildings survive in good condition looking out over open farmland. The agricultural grouping contributes to the area's semi-rural character and links with the Brookshill Drive character area.
